8.0	ACCIDENT ANALYSIS	8.1-1
8.1	OFF-NORMAL EVENTS	8.1-1
8.1.1	Transfer Cask Events	8.1-2
8.1.1.1	Misventing of Transfer Cask	8.1-2
8.1.1.2	Transfer Cask Drop Less Than Design Allowable Height	8.1-4

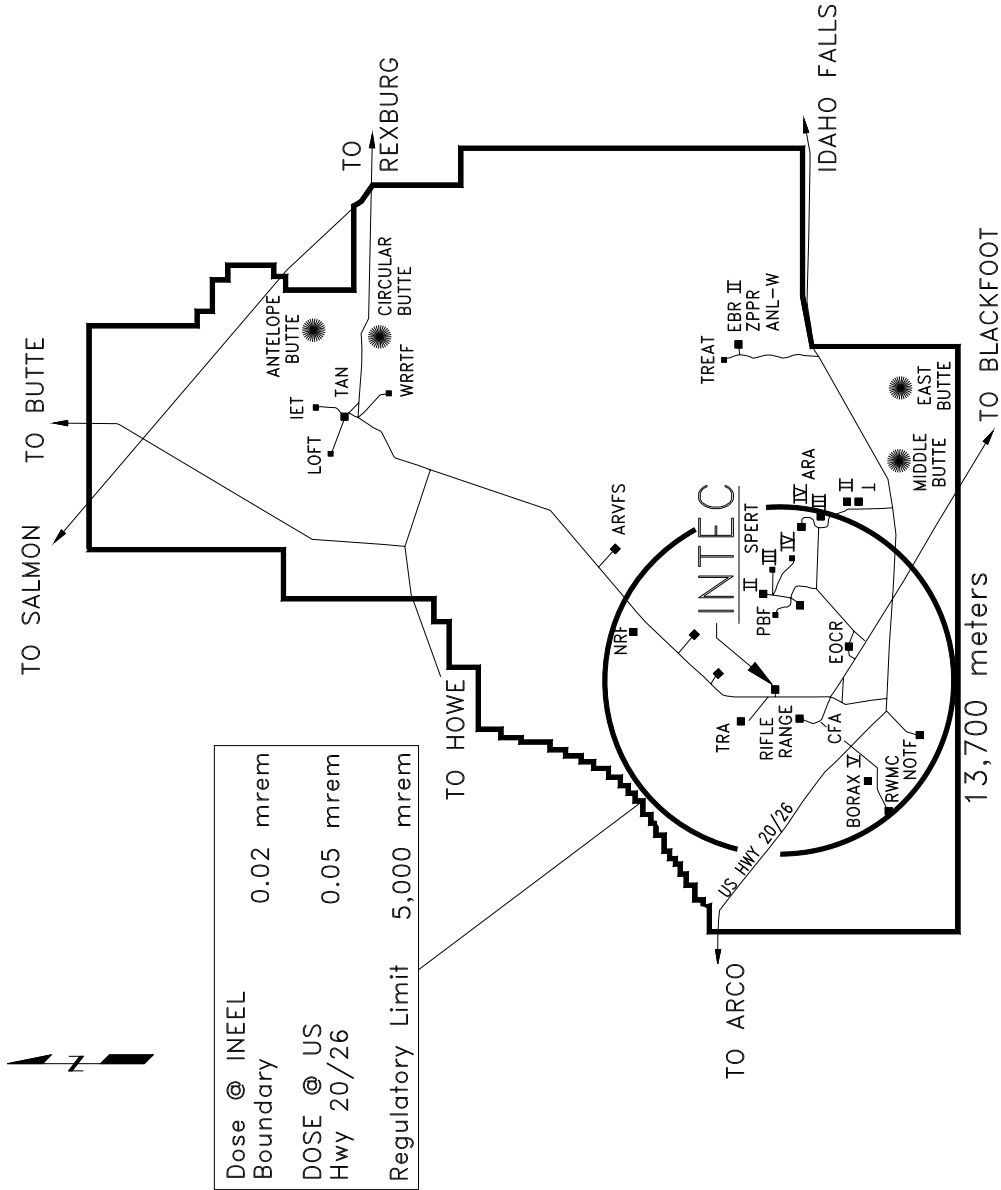
Figure 8.2-2
INL Area Maximum Dose For Non-Mechanistic Accident

The off-site radiological consequences of these non-mechanistic accidents were evaluated at the controlled area boundary. Based on the isotopic composition of the SNF types handled at the ISF Facility, Peach Bottom 2 fuel was identified as bounding for off-site dose consequences. The resulting dose for the ISF canister leak and FPA HEPA filter release at the closest controlled area boundary distance of 13,700 meters is 0.003 and 0.02 mrem TEDE, respectively. These calculated results are well below the 5,000 mrem accident dose limit of 10 CFR 72.106. Figures 8.2-1 and 8.2-2 provide dose results for distances closer to the ISF Facility for the bounding FPA HEPA filter release. The dose rates calculated for the nearer locations show that the resulting dose rates for workers at nearby facilities would be well below accepted regulatory limits.
